Blijdorp Zoo, Rotterdam, Holland

Case Study

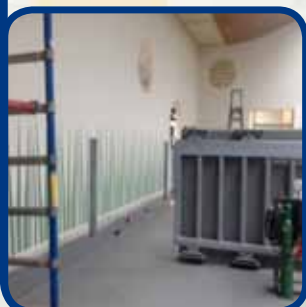
Following their evaluation of many alternative solutions that had been proposed, a 2-component coating system based on VIP polyurea resin technology was selected. The 900m² of concrete surfaces were prepared by blastcleaning, then a VIP solvent-free epoxy primer was applied as a surface sealer and water vapour barrier, followed by the VIP polyurea system which was applied using hot airless spray techniques. An additional advantage of this VIP polyurea system is that it can be applied and completed in a relatively short time, allowing other trades to continue and prevent delays, downtime and extended closures.
