SCA Packaging (North West) Ltd,

Case Study

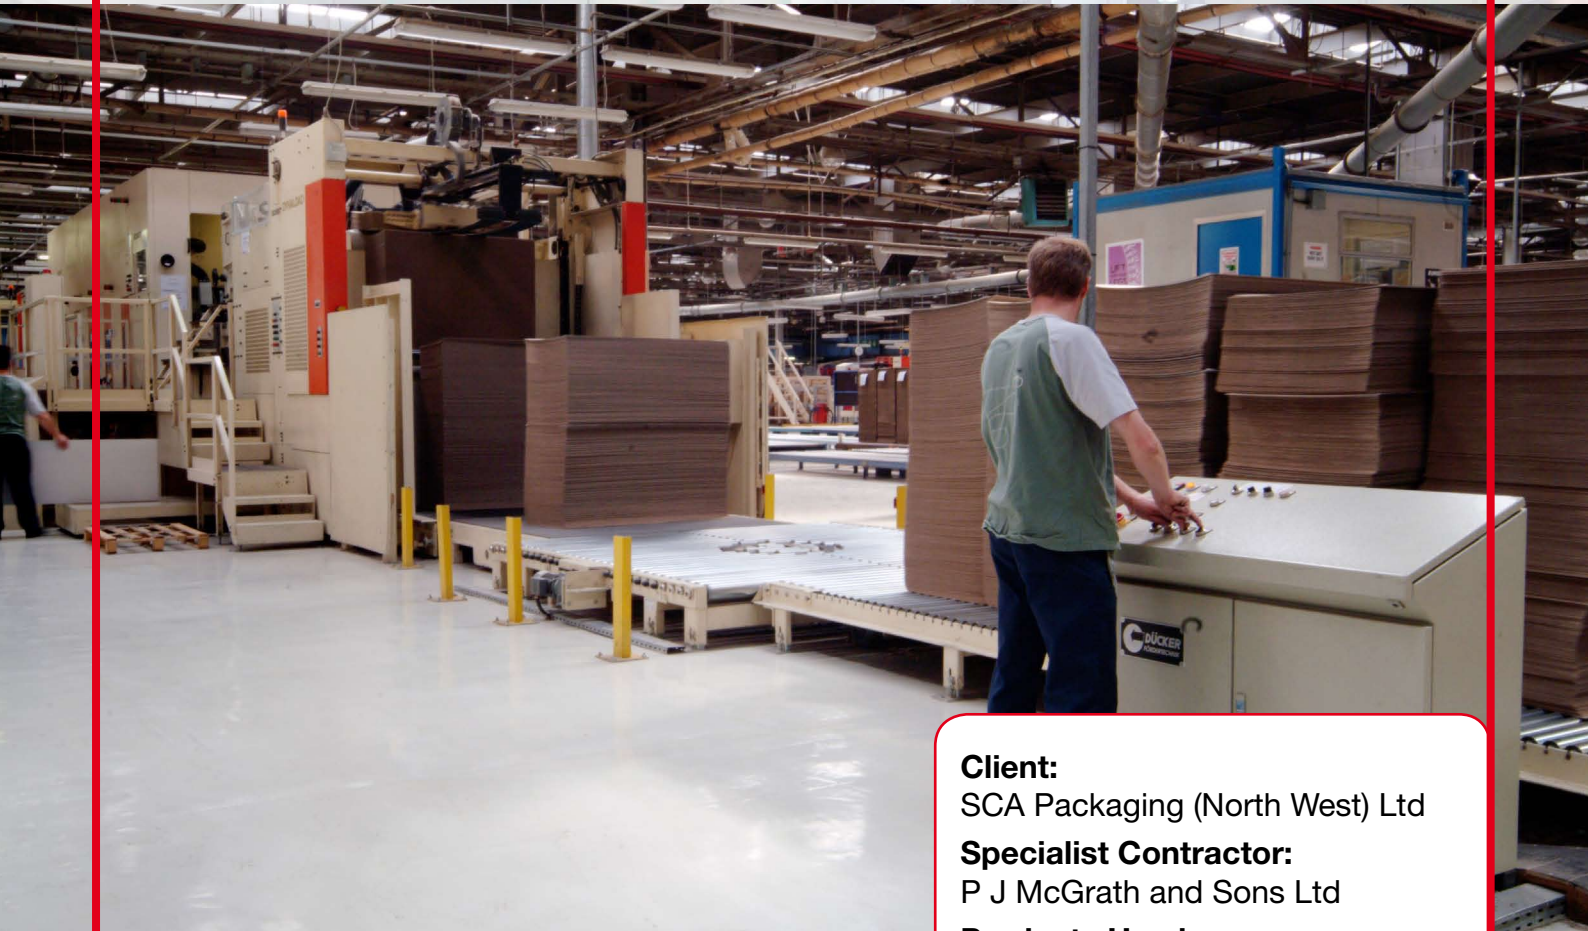
When SCA Packaging (North West) Ltd had difficulties with uneven and damaged floor areas, which were causing disruption and potential danger for their fork lift trucking operations – they called in **NCC** to provide advice and assistance – unbelievably still a free service offered by **NCC** in the region!

The client needed to repair the damaged floor areas, make good joint arrises and provide a level slip resistant surface finish.

NCC were able to propose a complete Sika System: Sikafloor 91 epoxy mortar to repair the damaged areas and reform the joint arrises, followed overall by Sikafloor 156 epoxy primer, and 2 coats of Sikafloor 261 solvent free epoxy coating, incorporating silica sand to give the desired degree of slip resistance.

Specialist local contractor P J McGrath & Sons was selected to carry out the works, which have now all been completed to the client's satisfaction.
