Denton Water Treatment Works, Greater Manchester

Case Study

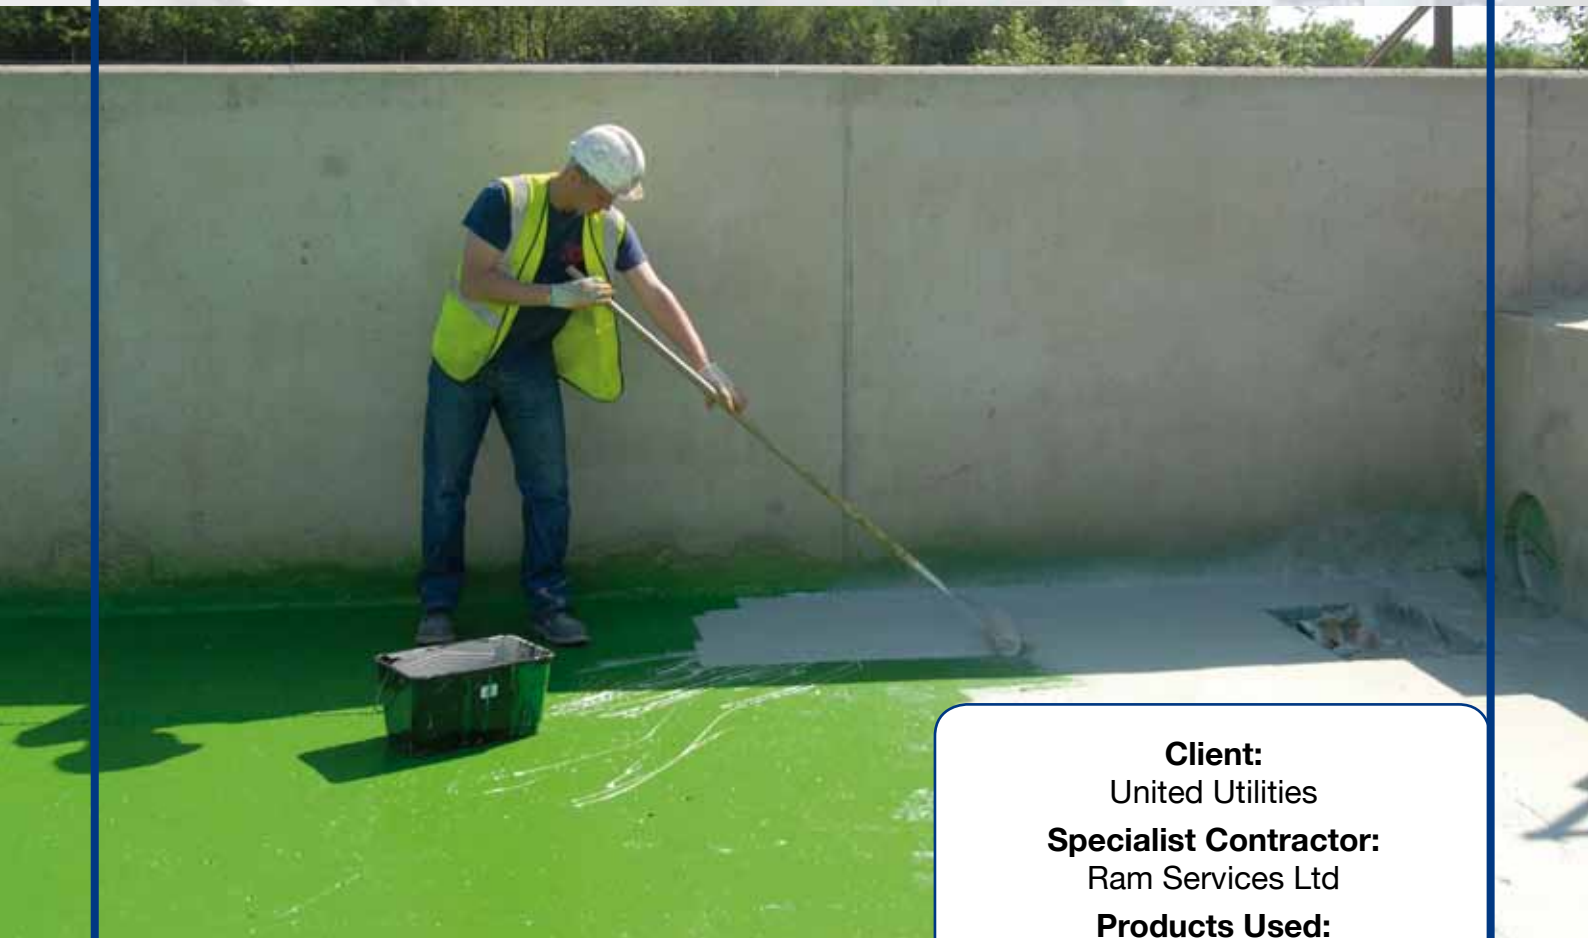
A high performance, Sikadur epoxy resin based, chemically resistant protective coating and lining system was supplied by NCC North West, to protect the refurbished concrete floor and wall surfaces against future chemical attack from the aggressive waste water at Denton Water Treatment Works.

The refurbishment process was firstly for the existing concrete to be cleaned and the damaged sections removed and repaired using fast-setting Sika epoxy resin mortars. Then all of the surfaces were protected with the highly chemically resistant, epoxy resin coating system, which was designed to prevent any future chemical attack of the concrete.
